BOLTON INTERCHANGE BOLLINGS YARD, BOLTON, UK

Kier Construction – Northern

BIG Biodiversity Challenge Award category: Small Scale Permanent Award & Pollinator

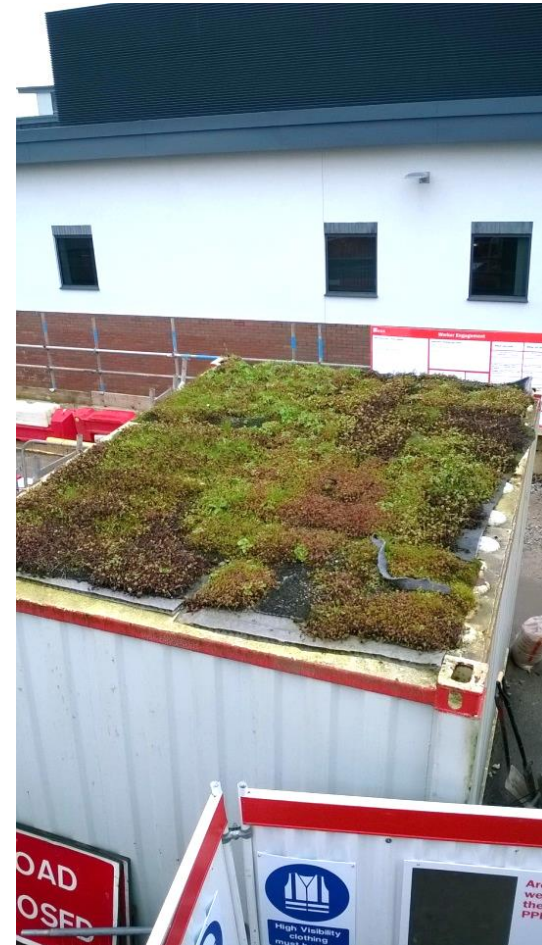
Site cabin Green roof

The highlight however has been the green roof on top of the crew and ops building. This is a new habitat created in the centre of town. This was laid in the summer. On a sunny day the amount of insects and bees that is attracted to the area is wonderful. This provides a wonderful view for the local residents who overlook the project. There was some excess green roof material left over the site team volunteered to place over the roof of a site cabin to further enhance the wildlife. It is possible to view the wildlife enjoying this from the 2nd tier site cabin. Which brings enhancement to the work force as this was enhanced green space .

For the green roof a drainage membrane was installed, and then a wildflower sedum was lifted in rolls onto the roof and knitted together. A gravel margin was added as basalt to the system. The sedum is required to be water everyday for the first year to ensure it establishes. Once established the sedum will rely on natural precipitation.

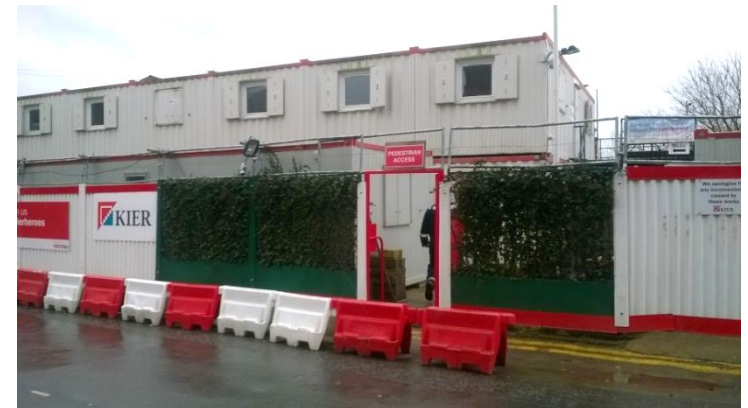
Green Wall

The 'Green wall' provides a warm welcome to the visitors and passers-by , by providing a piece of greenery in an otherwise build up area. The green wall has been easy to maintain, and would be easy to replicate on other projects, it provides enough security to the cabins.

The green wall was created by a planter being placed at the bottom on the heras fence, then ivy was planted and weaved through the fencing to create a visual barrier to the site cabins. In addition this helped reduced dust escaping from site, and therefore reduced the amount of water required for dust suppression.
