**Lamington Viaduct**  
**Lamington, South Lanarkshire, Scotland**  
**Amalgamated Construction Ltd / Network Rail**

**BIG Biodiversity Challenge Award category:** Medium Scale Permanent Award

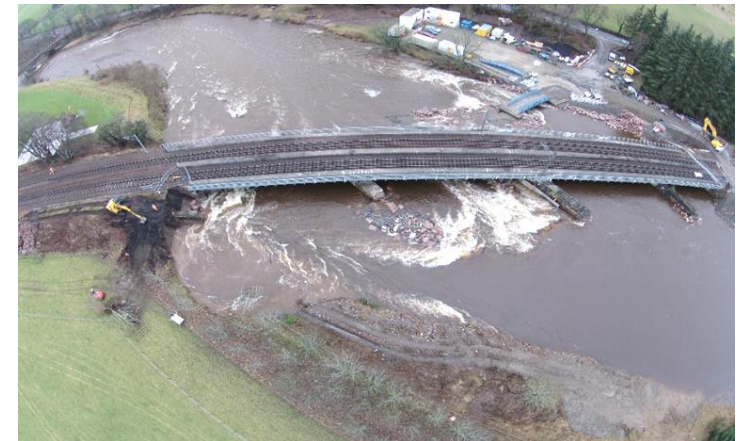
*Photo Description: Lamington Viaduct, January 2016. Prior to construction works commencing. Scour of the embankment evident*

A hard engineering solution using rock armour was required to protect 320m of embankment and our Client, Network Rail's, infrastructure against future erosion by the River Clyde. Working with our designer JBA, the AMCO Project team softened the engineering approach to allow greater integration with the surrounding landscape and improve the biodiversity benefit. Gaps between the rock armour were filled with soil and covered with pre-seeded coir matting which were then sown with a suitable national provenance wildflower-grass seed mix. The grassland mix provided a range of plants typical of a species-rich grassland found in Scotland. There were 16 wildflower and 6 grass species in this mix, which were suitable for pollinators.

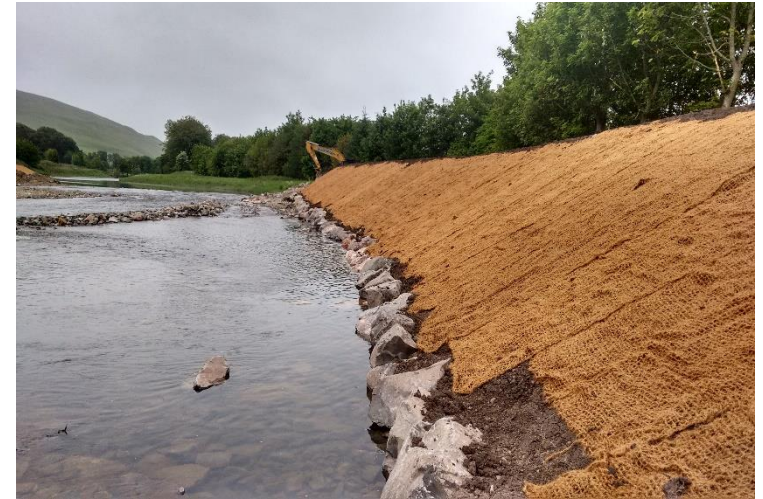
*Photo Description: Construction of the embankment - July 2016*

Additionally, as part of the reinstatement work, existing river gravels removed when the work commenced, were also reinstated where the bed had been reinforced under the bridge and along the toe of the embankment. This reuse of existing river gravels allowed the river bed to be restored to habitat similar to that which was present pre-construction.

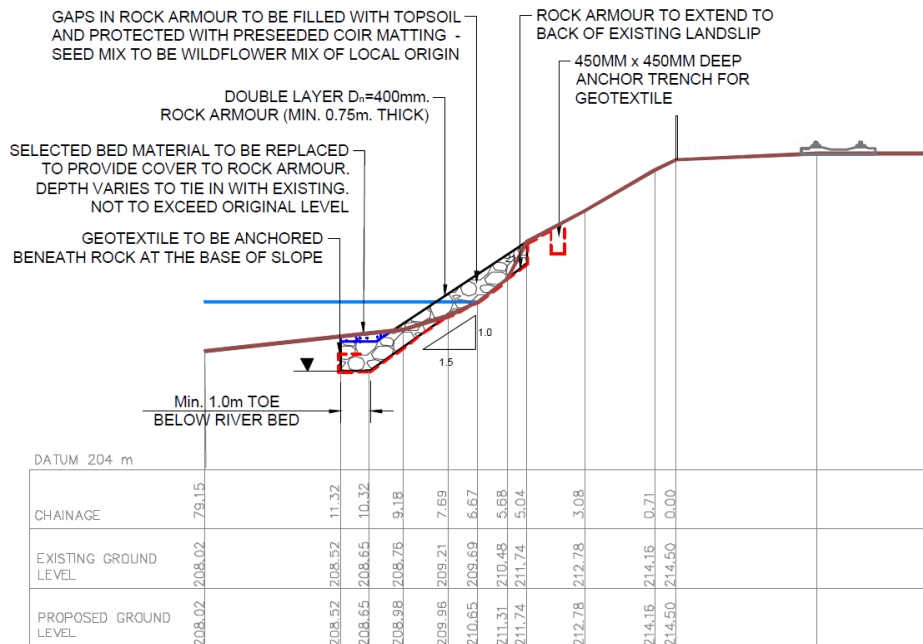
**SECTION S02**

The drawing below shows a typical cross section through the embankment.

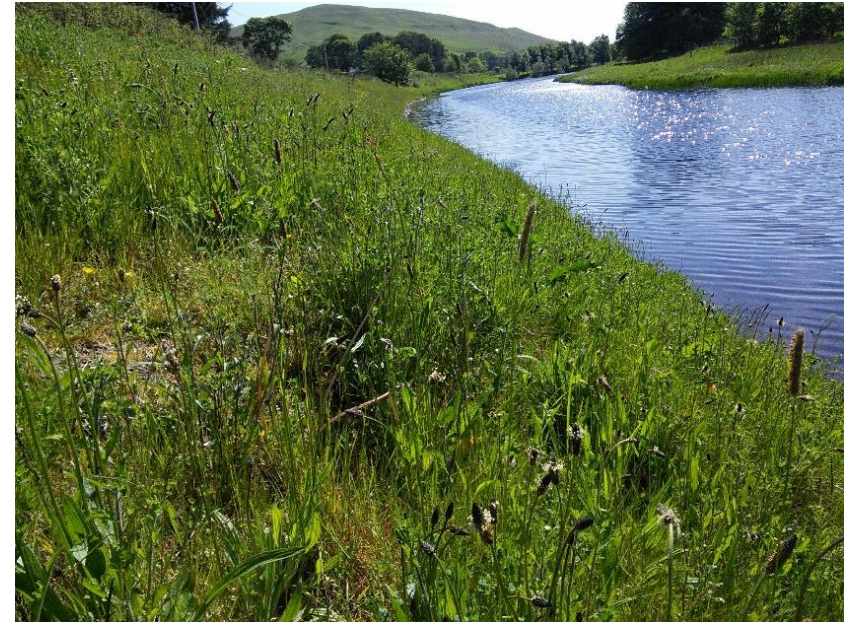
Photo Description: Lamington Viaduct Embankment – May 2017.
