Monks Brook Improvements – Installation of Pool and Run Habitats M27 Junction 5 Southampton, Hampshire

Highways England, EM Highways, Interserve, Wild Trout Trust (WTT)

BIG Challenge 2015 submission category: Large scale permanent

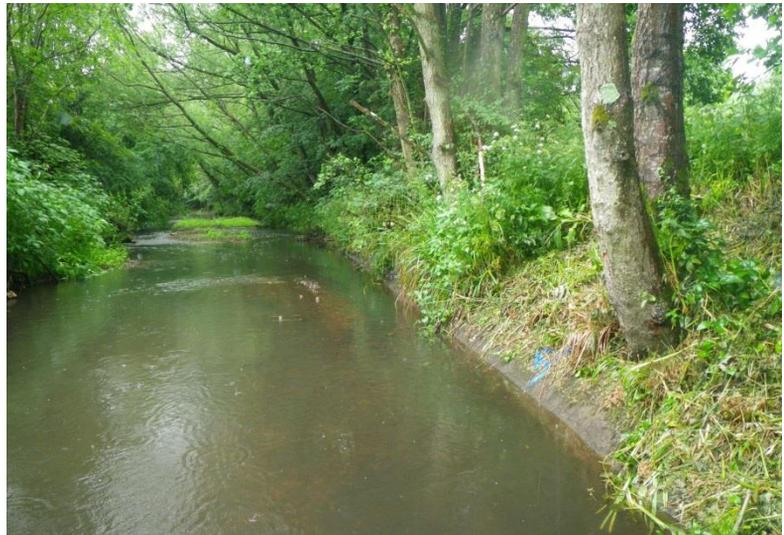
Photo: Before

The river throughout this reach has had significant channel modification and consisted almost entirely of very shallow glide running over mainly thin layer of deposited gravel overlying a concrete bed.

These hard, bare sections of bank and bed are sterile environments, providing no useful habitat for plants, invertebrates or fish.

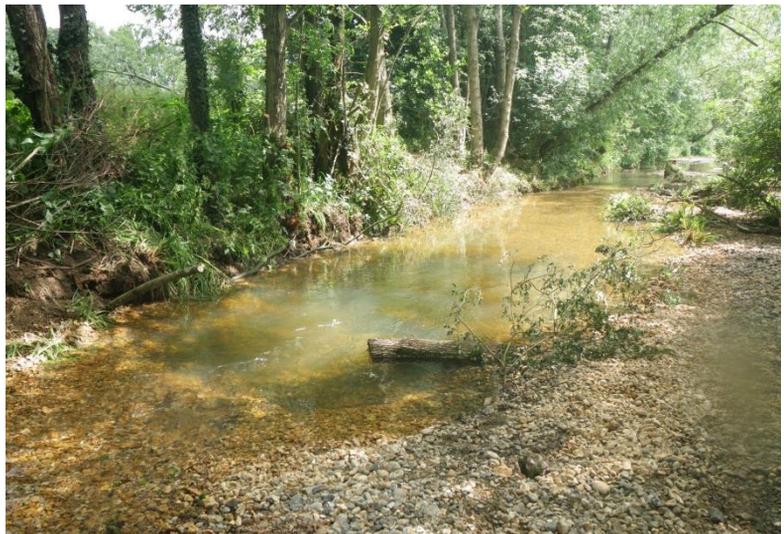
Photo: Completed top pool

It is too early to know if this has been successful. This collaborative work culminated in the construction of three distinct “pool and run” habitats that provide fish with both a safe refuge area to hold station and also provide optimal spawning opportunities.

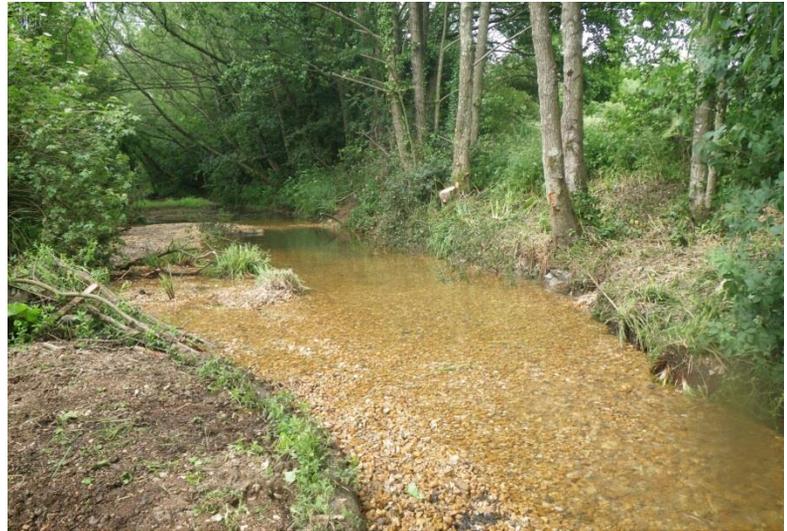
Photo: Tail of the run

Some additional 20-40mm gravel, of a suitable specification, was also imported to shape the tail of

the pools to provide ideal spawning environments.
