## Whittlesey Washes reservoir bank strengthening works Whittlesey, Cambridgeshire

Environment Agency, Interserve Construction Ltd, Royal HaskoningDHV

*BIG Challenge 2015 submission category: Small scale permanent*

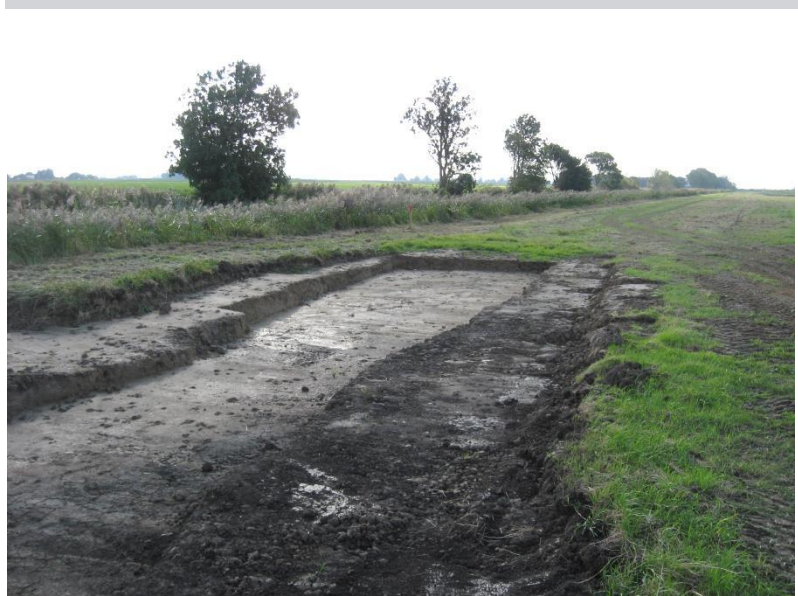
*Photo: Constructed scrape*

Wetland scrapes are manmade shallow depressions with sloping edges that seasonally hold water.

The locations, along the lower berm of the bank, for the scrapes were agreed with partners to provide additional marginal habitat for wading birds.

Material was excavated from the bank, to approximately 50cm above the water level in the Counter Drain, to create 20m<sup>2</sup> depression with shallow gradient slopes to provide easy access for bird and animal species.

Humps and hollows were created throughout to maximise diversity and it's been left to naturally recolonize by plant species.

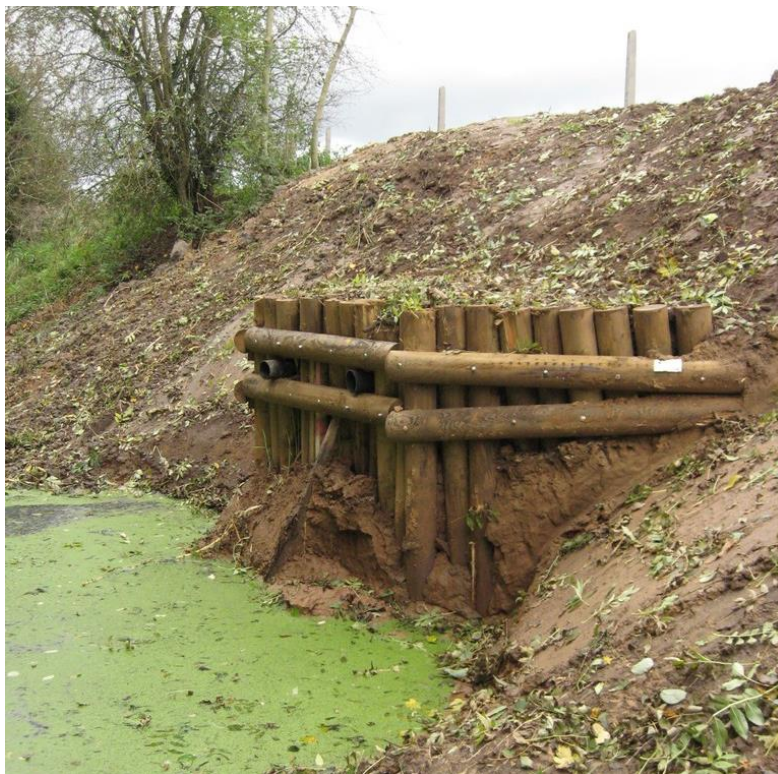
The kingfisher bank was constructed into the bank of a slow flowing stream (Counter Drain) with shallow areas of clear water and large overhanging branches for perching.

*Photo: Constructed kingfisher bank*

To create the Kingfisher Bank; vegetation was removed from a 5m long stretch of the bank and the face of the bank was required to be high enough to deter hunting animals and was designed to be vertical to minimise the risk of collapse.

The bank was built by driving recycled timber piles in an arc and then fixed with timber waling's to ensure stability.

Two pipes were introduced into the bank with a slow fall to the river to form potential nest sites. The bank was also scooped out at the base of the piles to draw water into the base. The bank was created 12 months ago and has been left for the kingfishers to naturally use and create their nests.

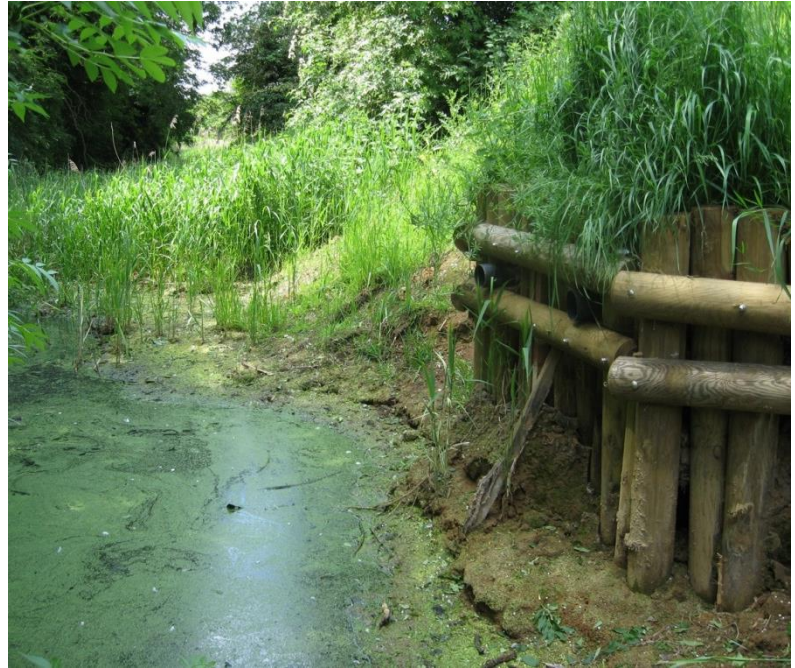
*Photo: Established kingfisher bank*

The RSPB have observed activity and 2 broods are currently using the habitat. The wetland Scrapes were easily created at no cost as
