**OFFICERS' MESS BAT HOUSE, VICTORY FIELDS,
UPPER RISSINGTON, GLOUCESTERSHIRE, ENGLAND**
LINDEN HOMES THAMES VALLEY

BIG Biodiversity Challenge Award Category: Small Scale

Project overview

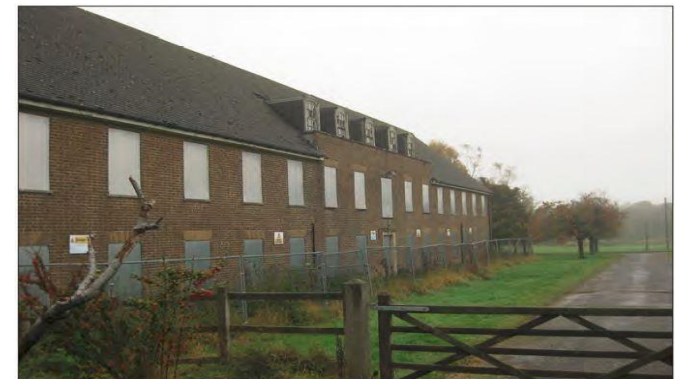
The Officer's Mess prior to renovation (photo: Aspect Ecology)

The derelict building was in an increasingly deteriorating state and ongoing vandalism had exacerbated this, threatening an eventual collapse and loss of habitat. Evidence of The Officers' Mess supporting satellite and hibernation roosts for Lesser Horseshoe Bat *Rhinolophus hipposideros* and Brown Longeared Bat *Plectous auritus* had been identified by prior surveys. Retention of the existing building was the preferred option as this would have a greater chance of being reoccupied than a replacement building and would comply with Natural England's requirement for minimal disruption by conducting works outside of the hibernation/roosting season.

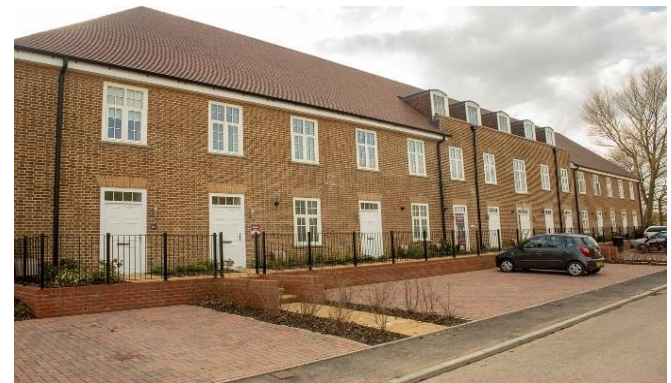
The Officer's Mess now completed (photo: S Hughes)

The entire overhaul of the roof space meant that a hazardous habitat for the bats (that would eventually collapse entirely) had been stabilised, but also massively enhanced. It is not clear what volume of the original roof space was available to the bats, though the previous bat population was minimal, but with the work that has been carried out now, we can be certain that the entire volume is available and accessible.

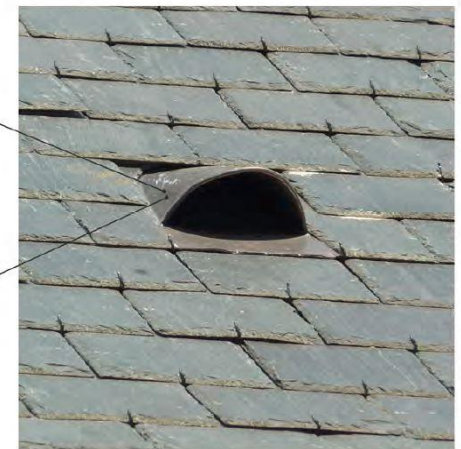
Tile constructed from lead with an opening to allow access for bats into the loft void.

Hooded entrance ensures the building remains weather-proof.

Access tiles to roof space similar to those used (Aspect Ecology)

The roof tiles were stripped before roof structural works could get underway. The species-specific roost ‘hot boxes’ were installed (for Lesser Horseshoe and Long Eared Brown bats) with integrated bat tubes for crevice dwelling species such as pipistrelles. The mock dormer access and roof tile access points were then installed before the roof was re-tiled.

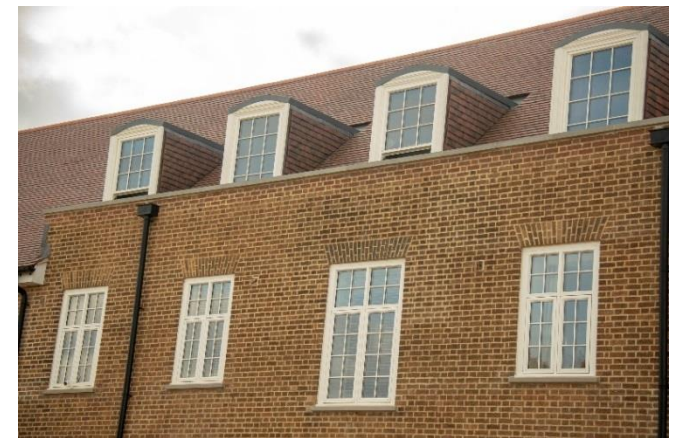
Mock dormer windows allowing access to roof roosting (S.Hughes)
