# Hamble Harbour – New Seawall Hamble Estuary, Hampshire, UK River Hamble Harbour Authority/Hampshire County Council, WSP, Suttles, Bournemouth University, Artecology

# **Project overview**

A new concrete seawall was required to replace >100 year old intertidal concrete frontage surrounding the base of the Hamble Harbour Master's building. The new seawall facing was completed with Reckli formliner and bespoke wooden moulds to create 'letterbox crevices' and integrated pools for sea life.

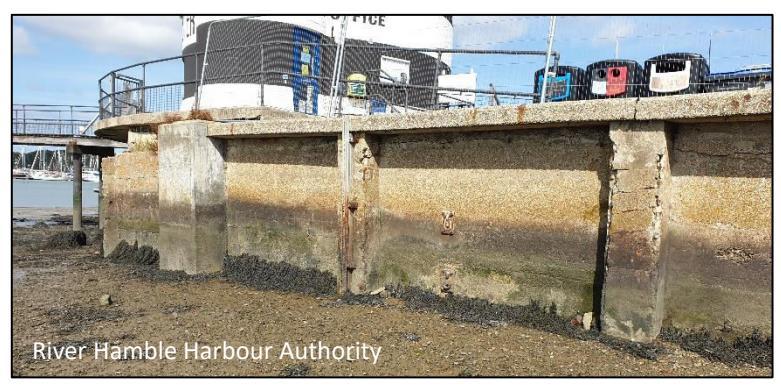
The >100 year old seawall in disrepair, photographed in August 2019

Three pre-characterisation surveys found just 12 species inhabiting the lower extent of the seawall, which was otherwise barren. Limited habitat was incidentally provided by cracks as a result of concrete deterioration and some canopy-forming algae at the base which provided shelter for the odd snail. The old seawall therefore had low value for wildlife, in addition to falling into disrepair.

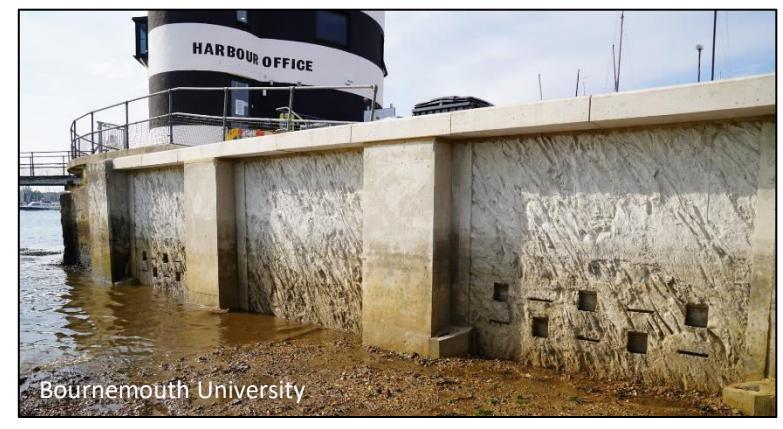
The new **seawall** in August 2021, showing textured surface and voids.

- A reusable Reckli formliner was used to increase surface area and texture, to increase shaded and wet areas on the seawall
- Concrete was made using recycled binder material GGBS to limit carbon footprint, reduce alkalinity for rapid primary colonisation, and increase the service life of the structure
- Wooden hollow boxes were nailed onto the formliner to create 'cubic' and 'letterbox' voids in the concrete frontage, adding further habitat features. The cubic voids slope inwards and downwards to retain water
- Pre-cast concrete rockpools 30cm in depth were placed at the toe of the seawall, providing additional habitat in the lower portion of the tidal range

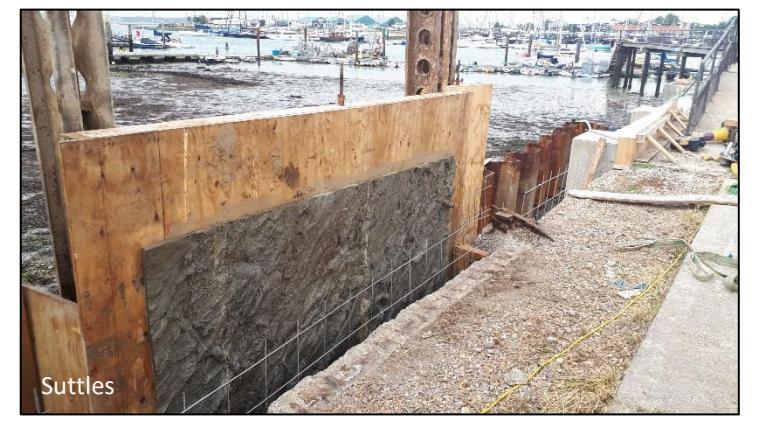
The Reckli textured form-liner in position for concrete to be poured for the Phase 1 seawall

The design of the seawall was a close collaboration between all parties, and engineers reported that the use of the form-liner was straightforward.

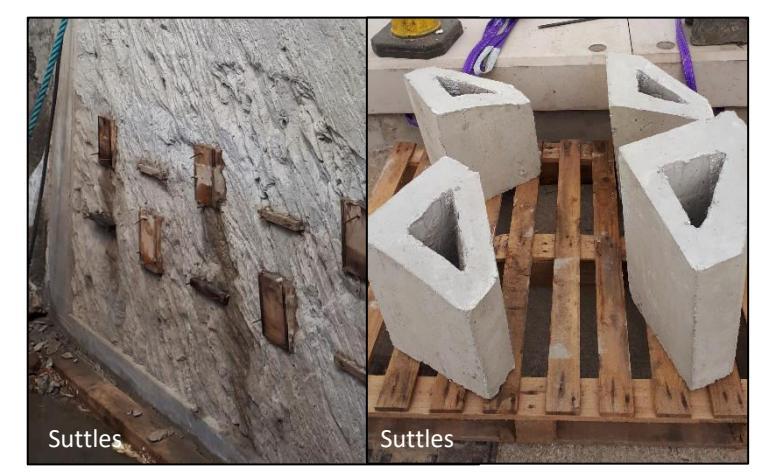
Left: the wooden moulds still in the seawall after the Reckli form-liner has been struck from the in-situ concrete seawall. Note the nails that pinned them to the form-liner. Right: the pre-cast rockpools

Although simple, the innovative use of wooden moulds to produce integrated macro-scale habitat features is feasible, inexpensive and easily replicable. The moulds can be adapted to any shape, size and height on the form-liner and can therefore be customised to each site and even each panel, and are quickly chiselled out of the seawall.

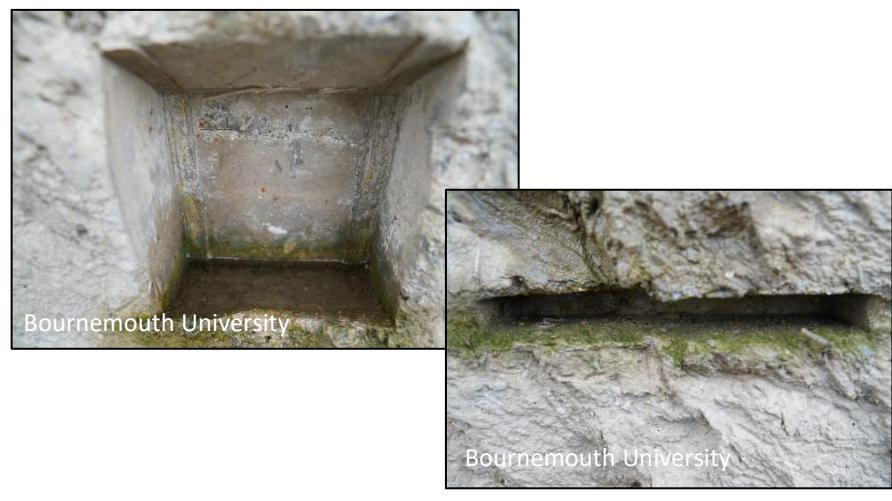
Left: a cubic void retaining water. Right: a letterbox crevice with a lip of green algae. Both photos taken two months post creation.

Mobile fauna such as sea snails and amphipods have already been observed using the puddled water in the cubic voids as shelter at low tide and would not have been able to do this without the habitat features included in this scheme. Although the high tidal range of the Phase 1 wall may limit colonisation today, in the decades to come it will provide life-saving stepping stones for intertidal sea life as sea level rises and our planet heats up.

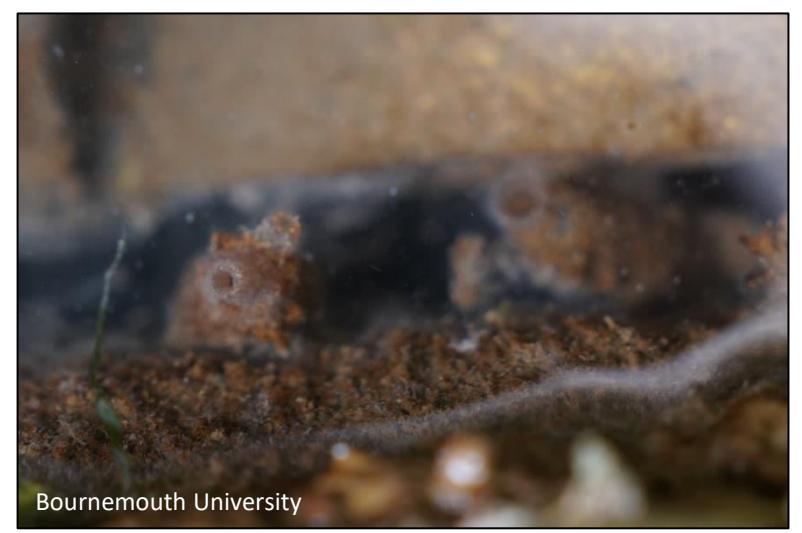
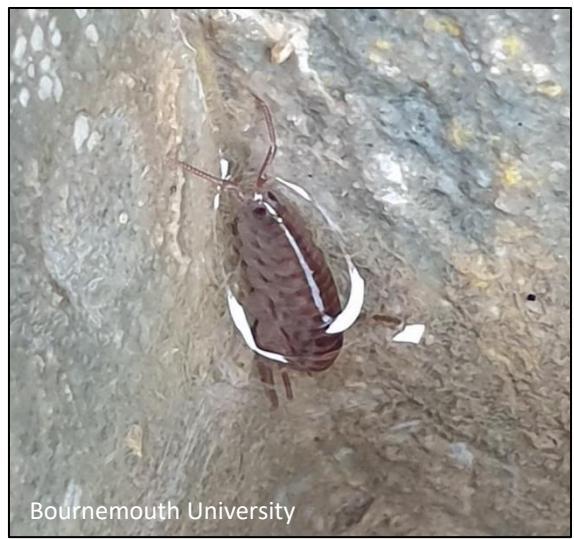
*Top: solitary sea squirts in the pre-cast rockpools at the toe of the Phase 1 seawall.*

Bottom: an amphipod hides in the water in one of the cubic voids
