Cannington Flood Alleviation Scheme
Cannington, Somerset
Kier Utilities/ Team Van Oord

BIG Biodiversity Challenge Award category: Medium Scale Permanent Award

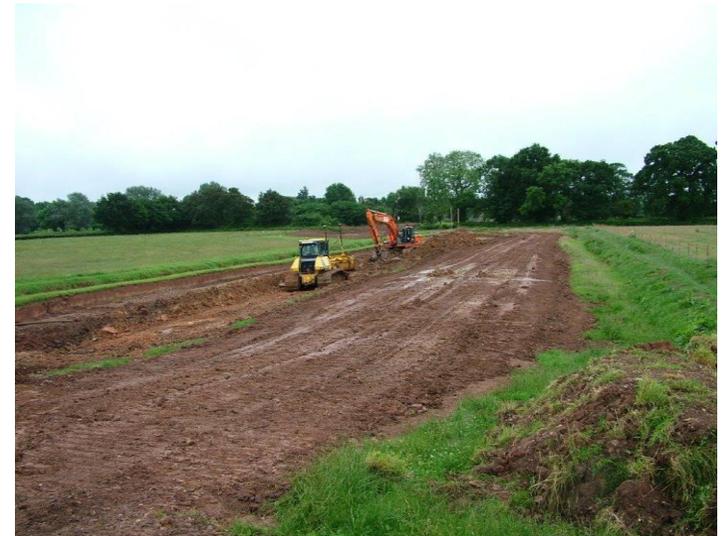
Groundworks start for new flood channel

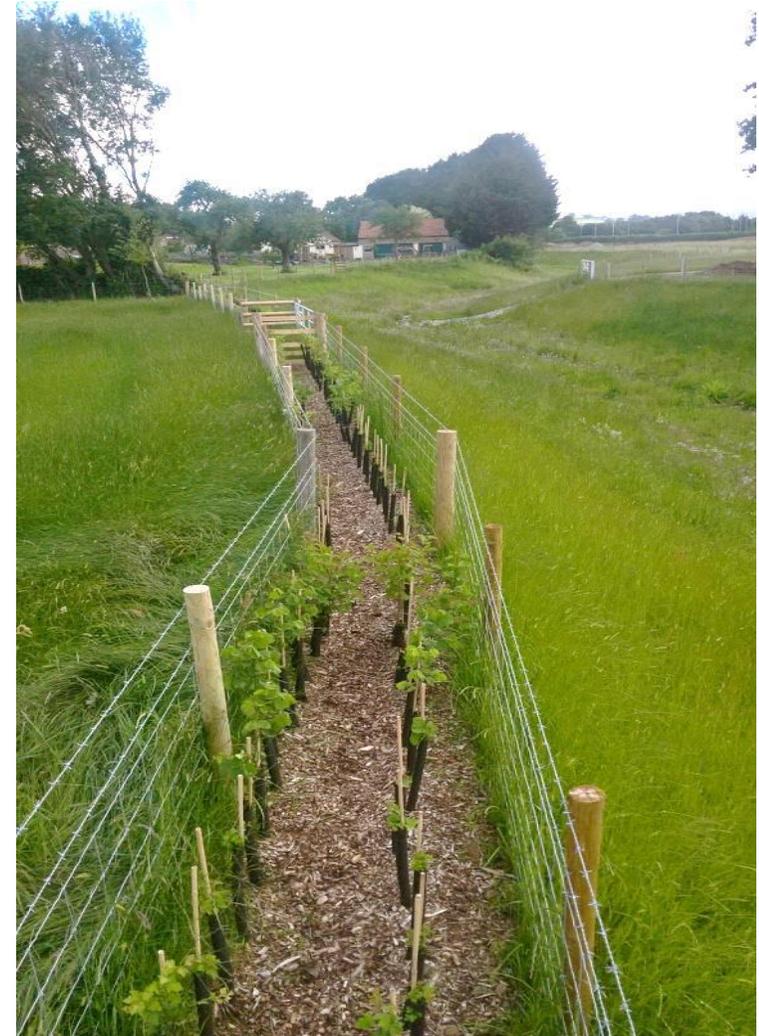
New hedgerow at Cannington

The scheme has been designed with landscaping and as such over 1000m of native species hedgerow has been planted. Species included, hawthorn, blackthorn, holly and hazel. The hedge will help visually screen the new flood channel and will also help stabilise the soil and absorb water in the area.

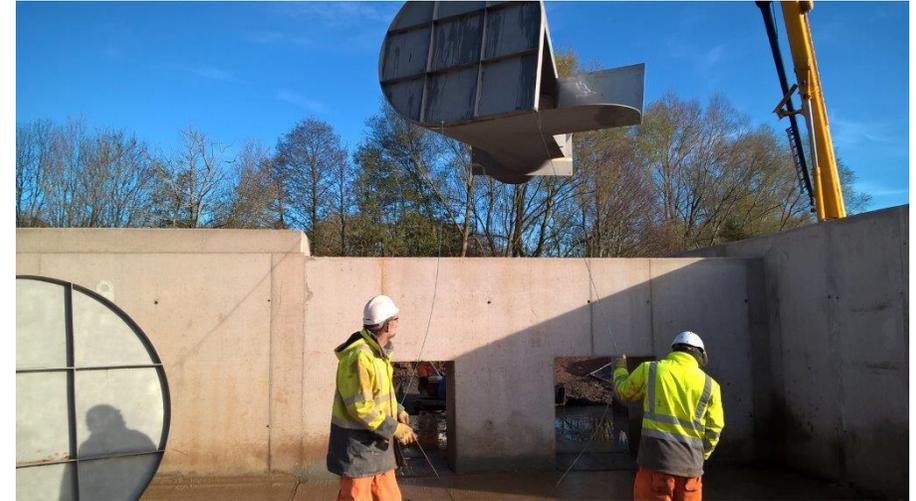
Hydrobreaks being added to new flood channel
