## Allsmoor Pond Refurbishment Bracknell Optimise Water LLP (working on behalf of Thames Water)

BIG Biodiversity Challenge Award category: Medium Scale Enhancement

### Project overview

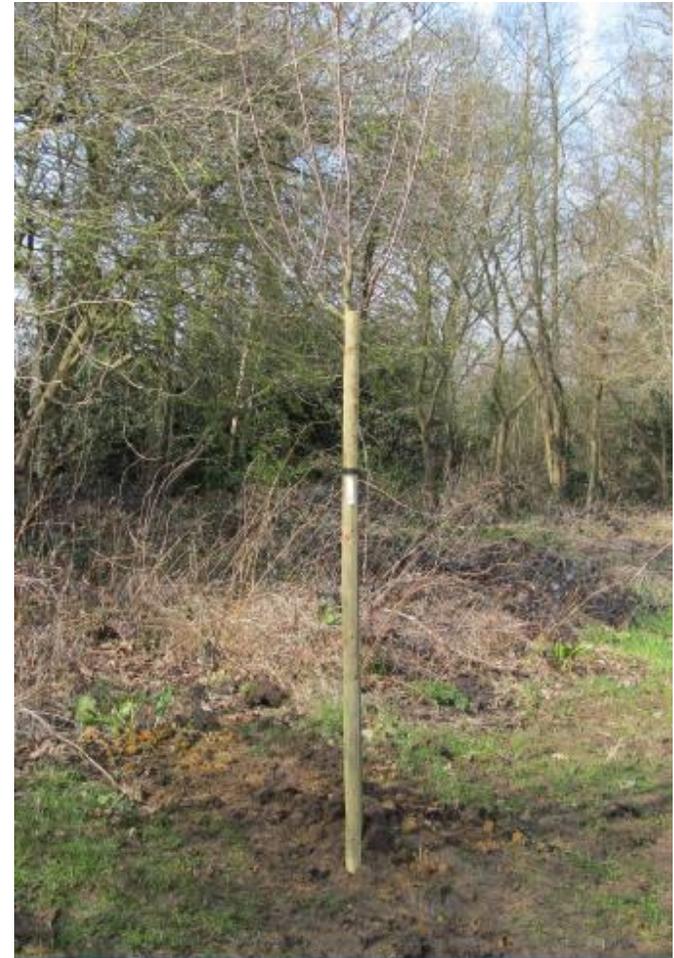
*Clockwise from right: (1 and 2) the collapsing hard engineered edge to the pond prior to works, with no edge vegetation; (3) The new benches and new pond edge, including coir roll.; (4) Finally, the coir roll planting has matured and a local resident enjoying the view provides feedback to Optimise.*

The need related to footpath safety. There were two 40 metre sections of brick retaining walls on the north and south side of this pond which had been slowly collapsing towards the pond, creating a safety hazard. The aim of the project was to find a design solution which would reinstate this wall and in a way which was in keeping with the surrounding environment.

To refurbish the wall, a limestone revetment was built within the pond on both sides. The revetment, when the water levels in the pond are low, would be visible above the water line. A landscape architect was engaged to consider how to improve the visual appearance and enhance biodiversity. As such, coir rolls pre-seeded with riparian plant species including *Iris pseudoacorus*; *Caltha palustris*; *Carex acutiformis*; and *Lythrum salicaria* were placed within the rock revetment to soften the visual impact of the revetment.

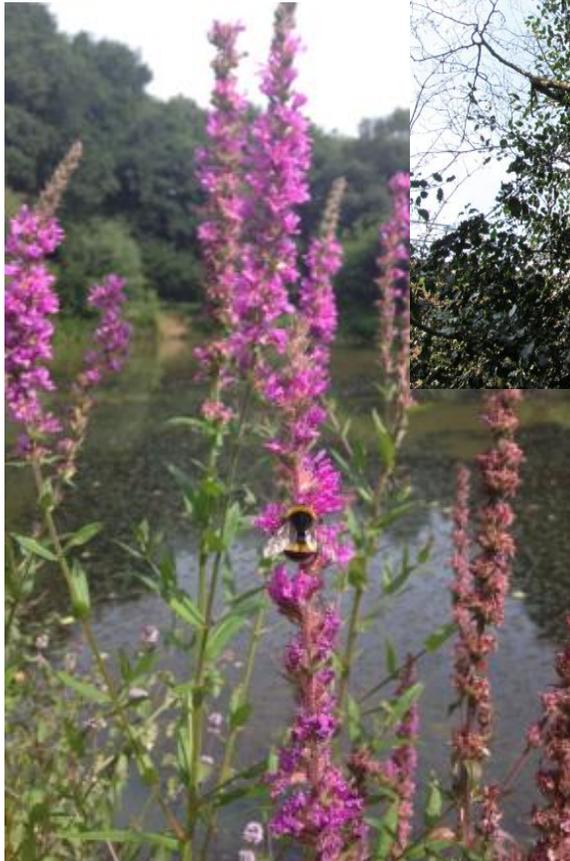
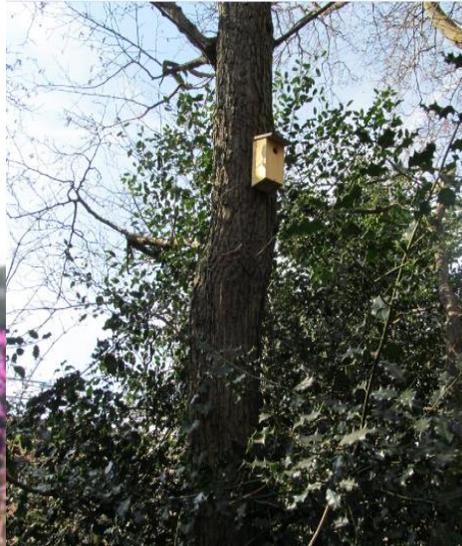
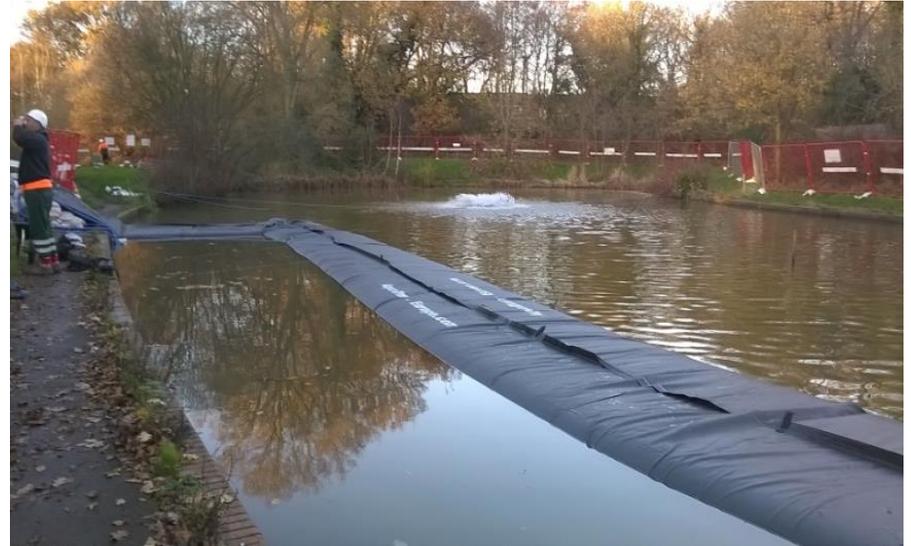
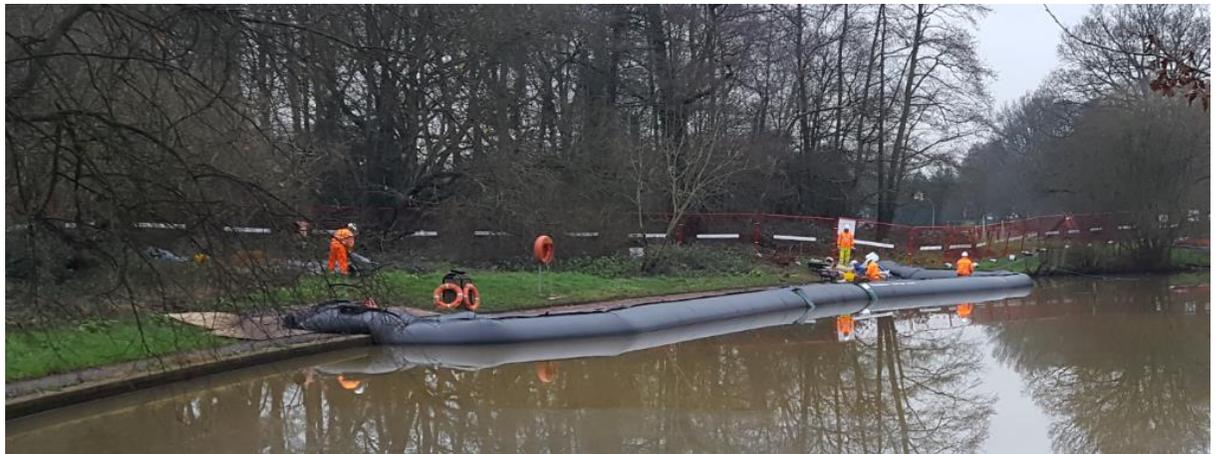
*Clockwise from top right: (1 and 2) the aquadam installed during construction to minimise noise, vibration and silt impact on fish. In (1) the oxygenation is visible; (2) The pre-planted coir rolls have established and Lythrum salicaria is a hit with bees and butterflies; (3) Bird box installed during community planting day.*

In addition to the permanent enhancement measures, during construction works, a number of mitigation measures were employed to minimise the impacts. A fish survey was undertaken to assess the health, size and population of the fish within the pond. Measures were taken including the use of an aquadam - a low impact technique to secure dry working conditions that avoids the noise and vibration of sheet piling, oxygen was artificially pumped into the pond to compensate for the turbidity, and water sampling was undertaken to ensure that the fish were not harmed.
